Report: Main St 123 Address: 123 Main Street

Confidential Inspection Report

123 Main Street
Vienna, VA

August 24, 2023

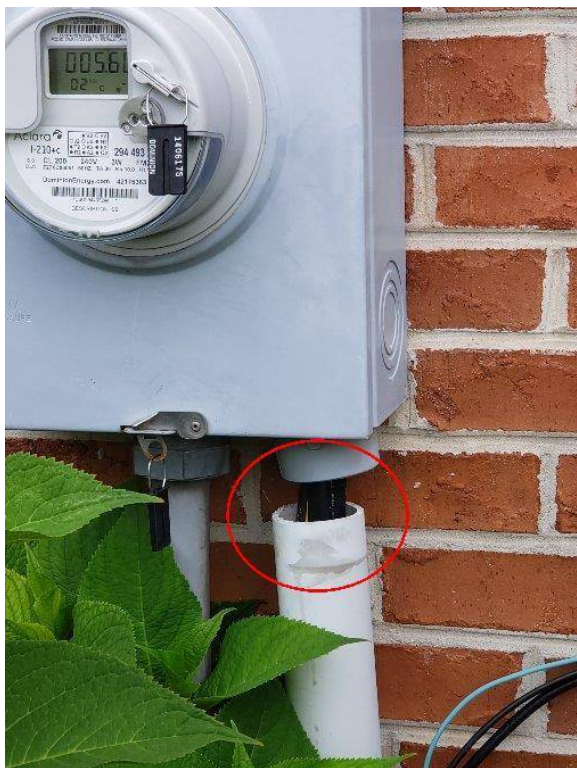
Damage Noted: Electrical Conduit has settle pulling conduit away from meter box. Electrician needed for repair (contact utility company first)

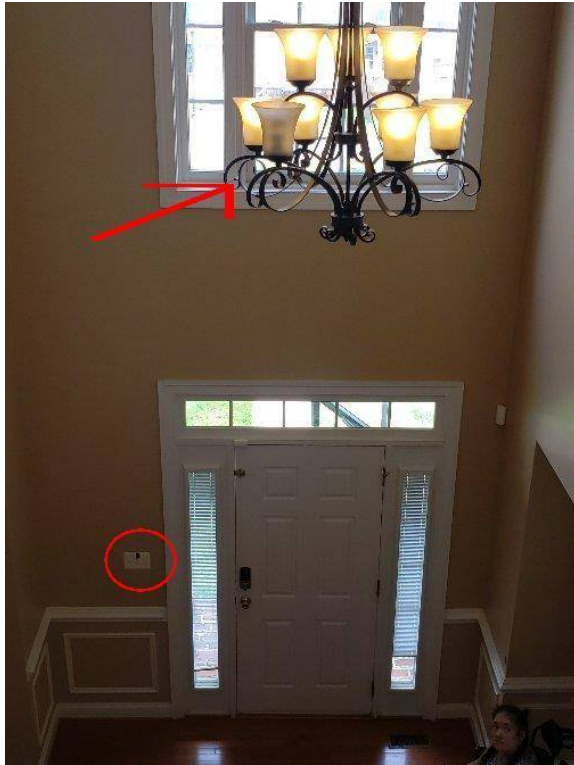
The 3-way foyer chandelier light installed did not function using the two wall switches. Electrician needed for repair.

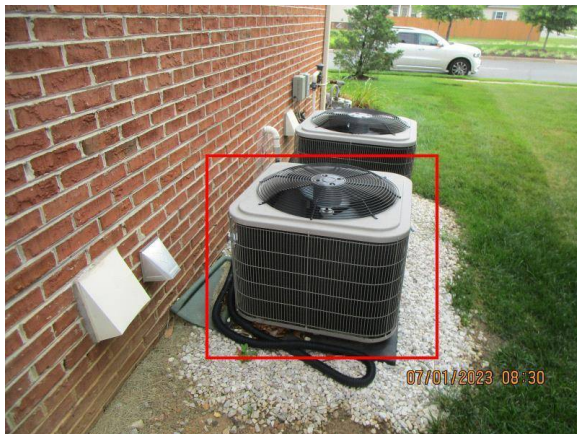
Lower zone, AC Unit not producing an adequate air temperature drop. Further evaluation and repair will be needed by a qualified air conditioning contractor.

Expect refrigerant needed in refrigerant line.

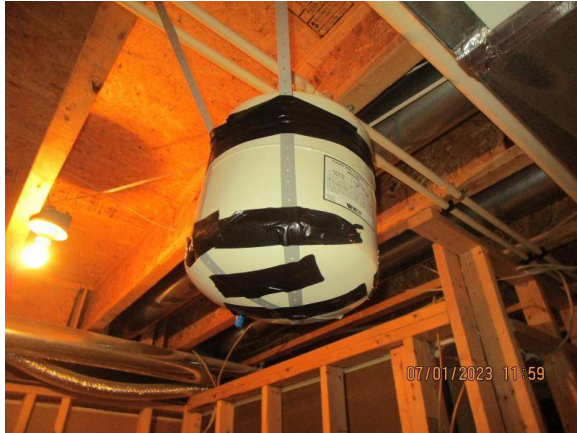
Expansion tank is waterlogged. Plumber needed to replace expansion tank. Suggest expansion tank be relocated over water heater at Cold Water line with proper hangers.

Water heater is beyond it's normal life expectancy and should be routinely monitored.

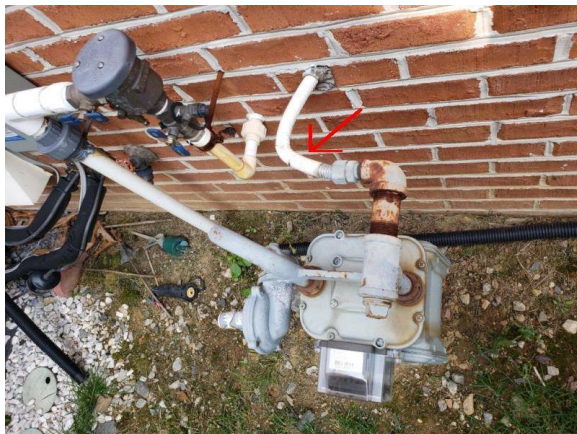
Corrugated Stainless Steel Tubing (CSST) flexible piping used for gas supply.

Risk of electrical strike damaging CSST which could lead fire or to a gas explosion. For correction Gas Lines should be bonded to grounding electrode. Have corrected by Electrician to be attached to closest electrical panel ground.

Exterior CSST gas line should be protected in conduit.

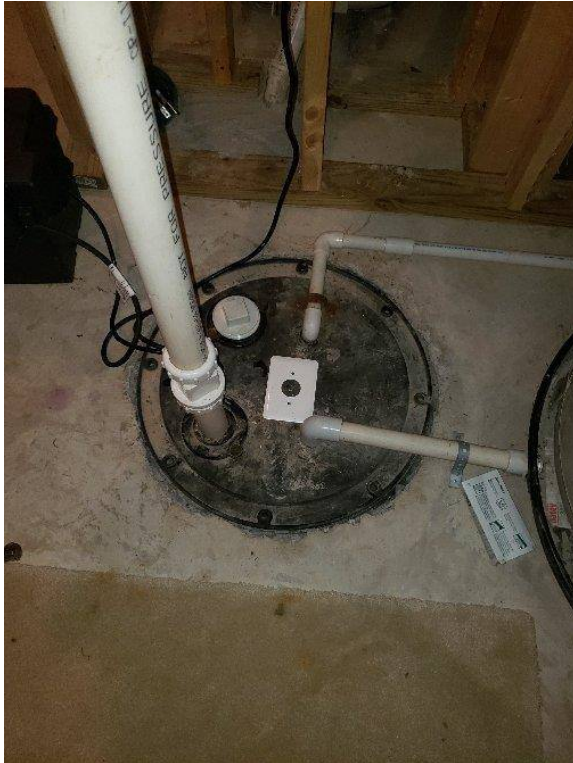
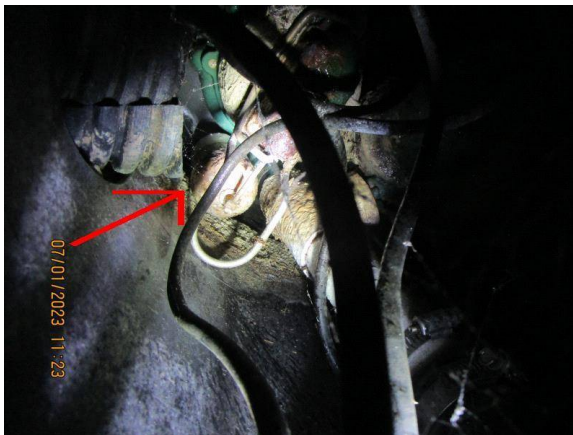
Sump Pump float rubs up against sump crock wall fails to turn off. Free up float so pump will properly operate on and off.

Identify end of exterior drain. Suggest stones or pop-up device be installed where drain daylights.

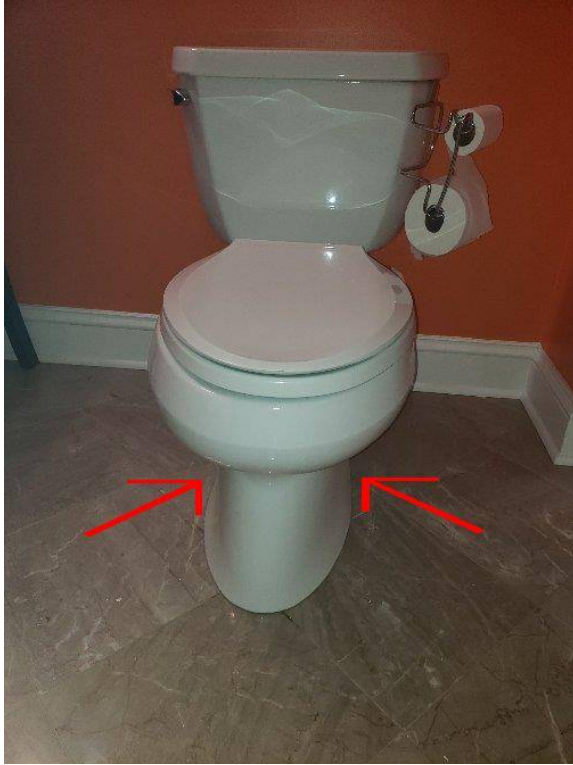
Basement Bath: Toilet bowl is loose at flange, Flange bolts may be detached from flange. Toilet should be reset by plumber with new wax ring if tightening bolts fail to secure toilet in place.

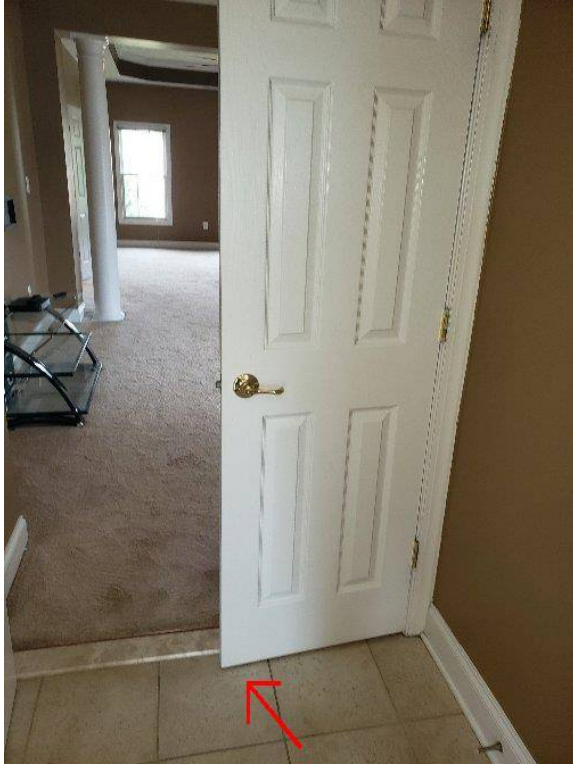
Powder Bath Door hardware needs adjustment or repair to latch. Adjust strike plate so that the door will properly latch.

Primary Bath: Door rub/sticks/won't close, Trim down door so that the door will properly latch.

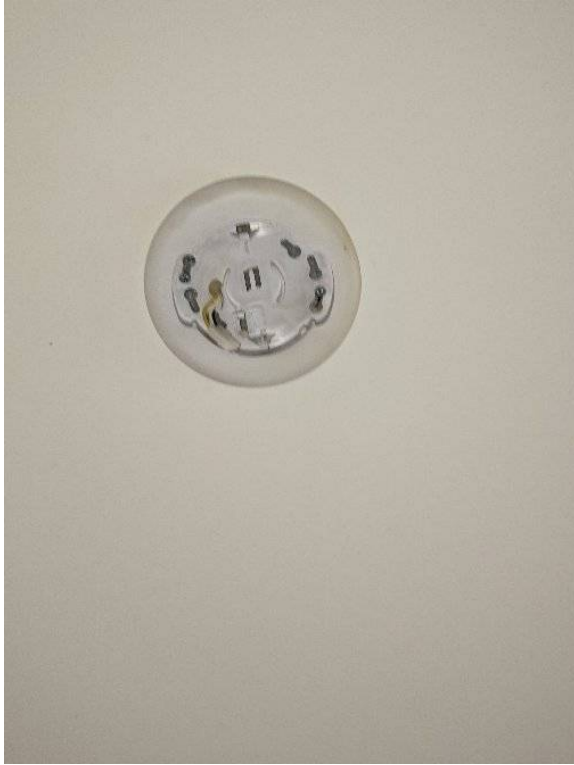
Hardwired smoke detectors interconnected. Suggest a CO Detector on floors with gas fuel ignition.

2 Smoke detector covers missing on upper bedroom level and Hall and bedroom. Several Other detectors failed to operate when tested. Suggest replacing or repairing all smoke detectors to operate properly.

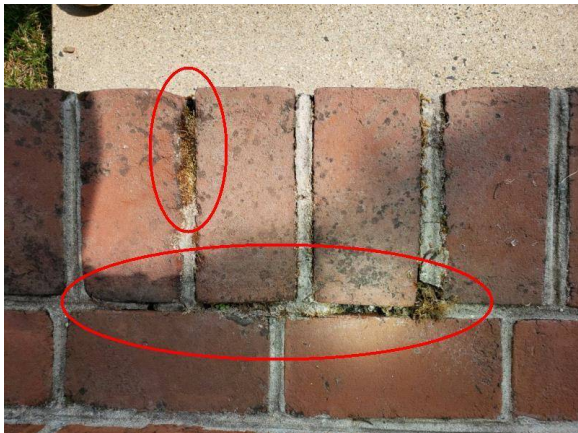
Several bricks in need of repair. Repair bricks as needed to prevent spalling from water penetration.

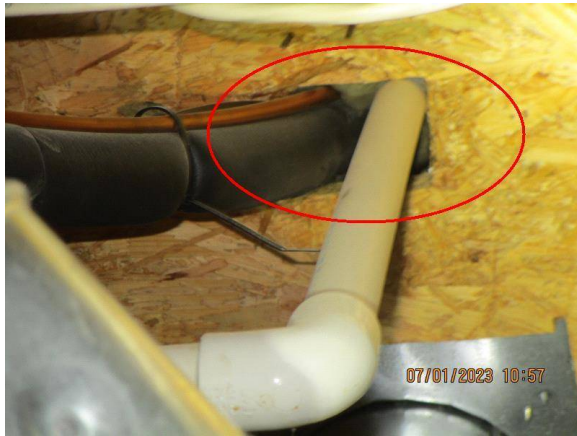
Fire block material needed around condensate drain and refrigerant line passing up through ceiling into

attic.

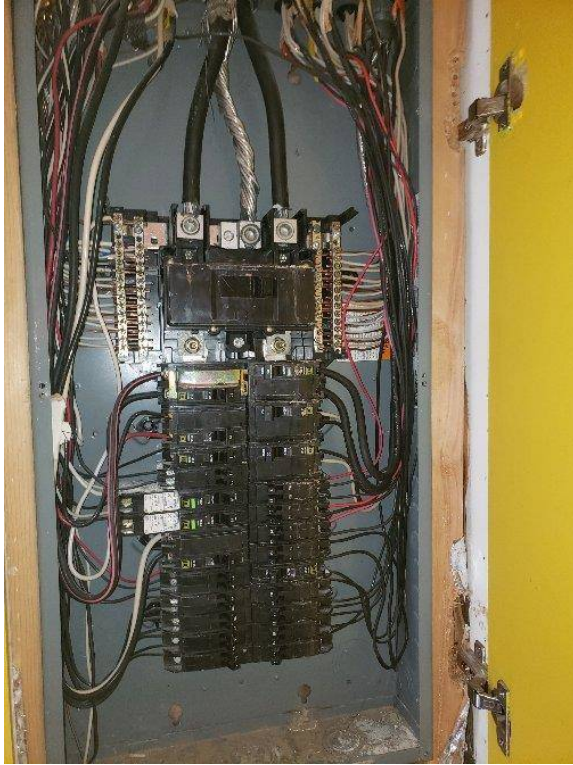
Panel without occupancy permit. The permit contains a list of county inspectors that has signed off once all areas are satisfied. Most permits are attached to panel door. When replacing panel the permit should stay with new panel.

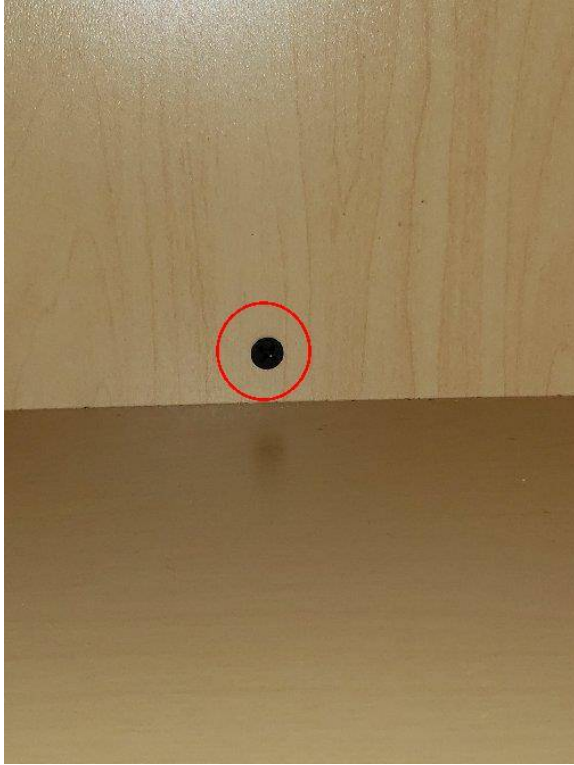
Cabinets installed with wrong type screws. Drywall counter-sunk screws may shear and pull away from wall. Replace with proper stainless pan-head cabinet screws (usually found in paint department in hardware stores)

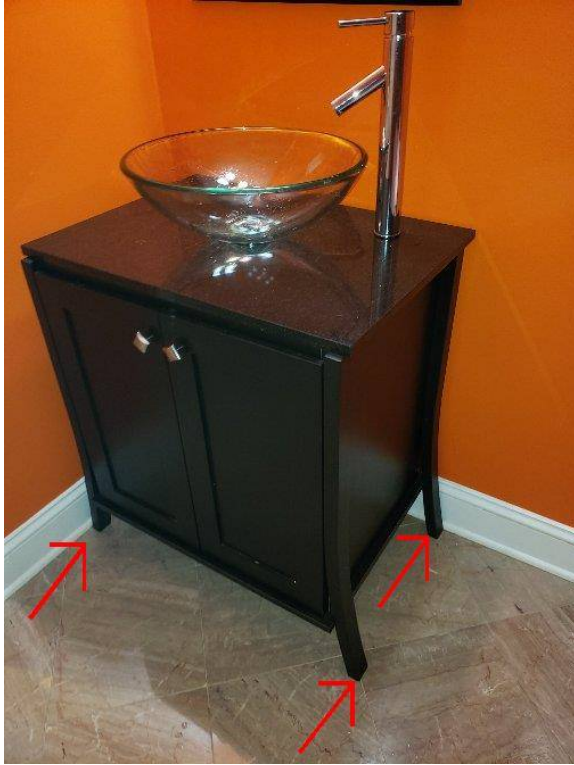
Basement Bath: Vanity cabinet not attached to wall or floor and loose on floor. Properly secure legs the floor.

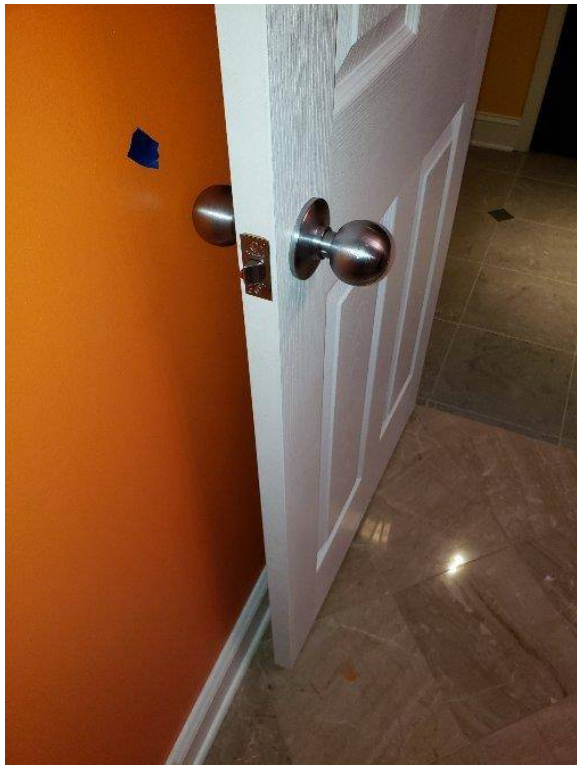
Basement Bath: Door stop needed.

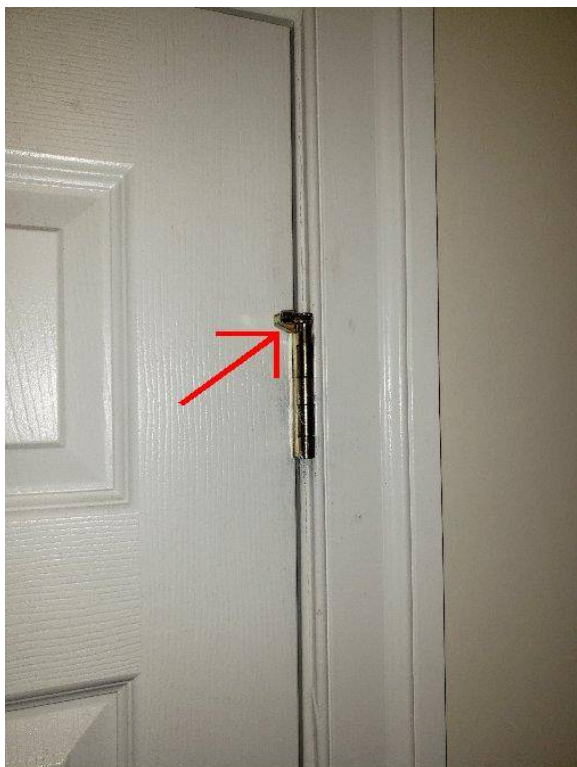
General condition appears serviceable,
Door stop needed on door.

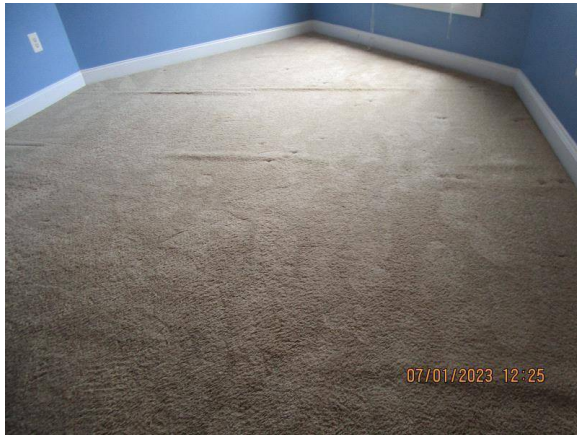
Upper Floor bedrooms and hall carpeting is loose. Carpet in good condition but should be stretched by carpeting specialist.

Professional carpet cleaning needed in primary bedroom.

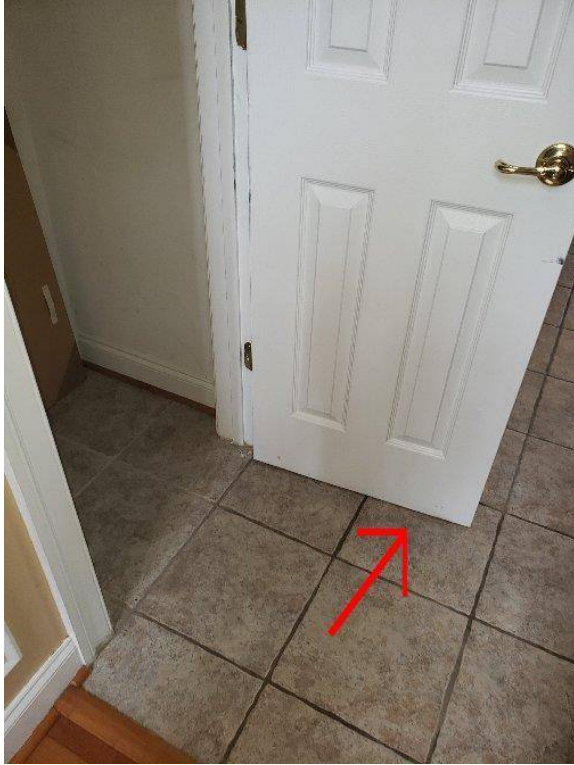
Coat closet door rubs/sticks. Repair door to properly operate.

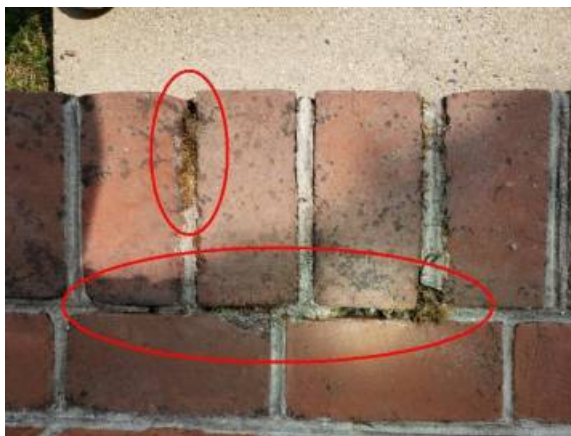
| | OK | MM | RR | |
|---|---|---|---|--|
| Exterior Steps / Stoops: | <input type="checkbox"/> | <input checked="" type="checkbox"/> | <input type="checkbox"/> | Steps are constructed of bricks, Portico roof over front porch is present. Several bricks in need of repair. Repair bricks as needed to prevent spalling from water penetration. |

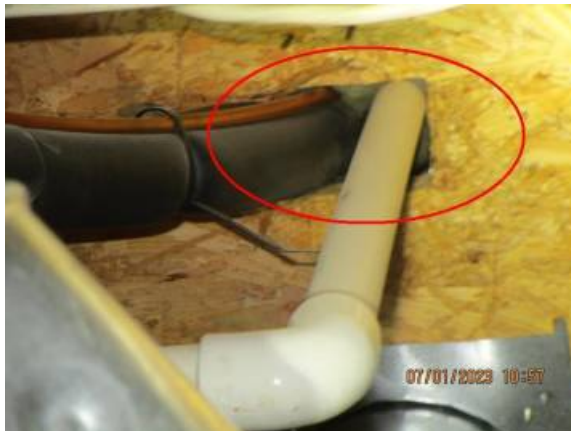
Floor joists are TJI type joist (like an I-Beam) with OSB Sub-Floor.
Fire block material needed around condensate drain and refrigerant line passing up through ceiling into attic.

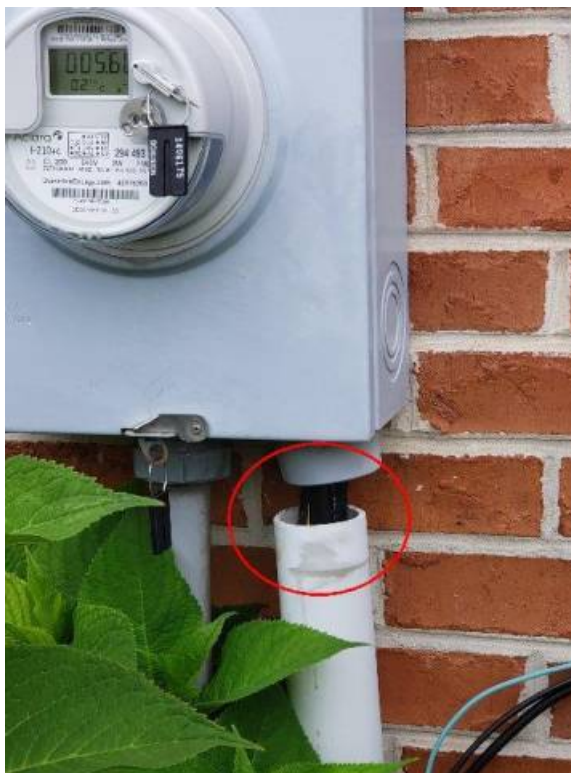
Damage Noted: Electrical Conduit has settle pulling conduit away from meter box. Electrician needed for repair (contact utility company first)

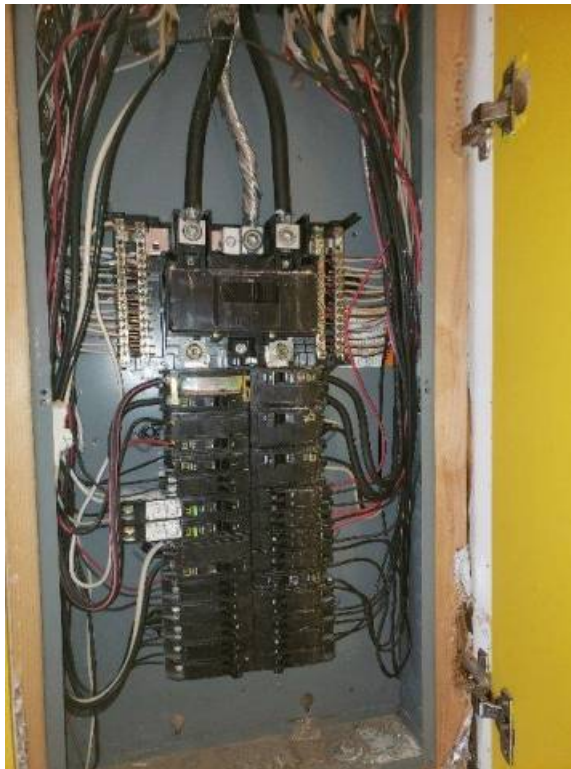
Panel without occupancy permit. The permit contains a list of county inspectors that has signed off once all areas are satisfied. Most permits are attached to panel door. When replacing panel the permit should stay with new panel.

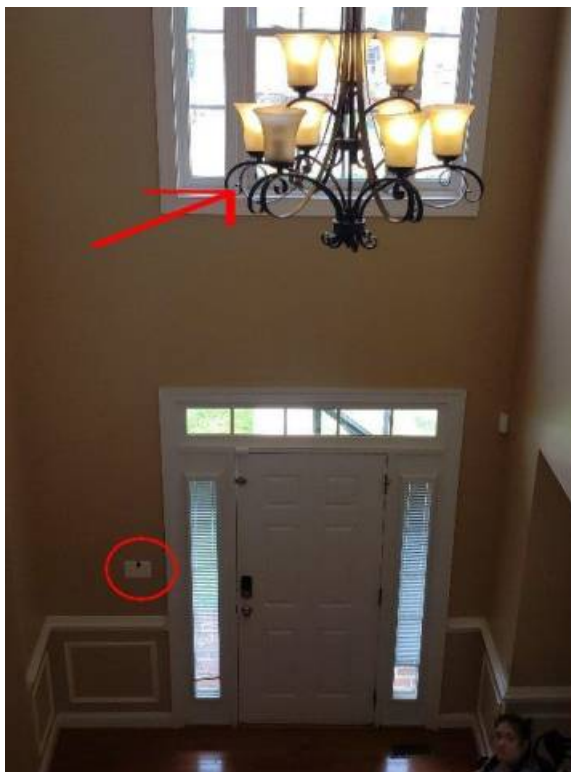
| <input type="checkbox"/> | <input type="checkbox"/> | <input checked="" type="checkbox"/> | The 3-way foyer chandelier light installed did not function using the two wall switches. Electrician needed for repair. |

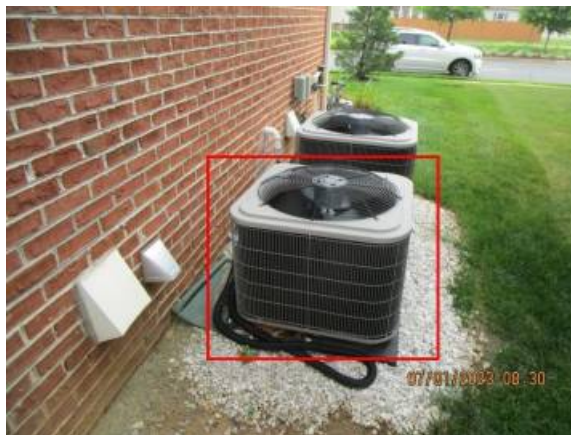
**Lower zone, AC Unit not producing an adequate air temperature drop. Further evaluation and repair will be needed by a qualified air conditioning contractor.
Expect refrigerant needed in refrigerant line.**

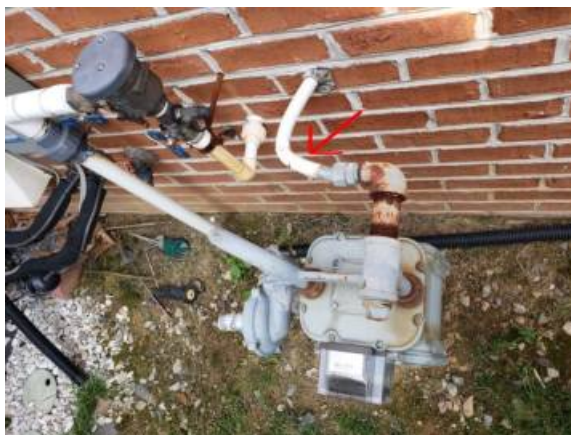
Exterior CSST gas line should be protected in conduit.

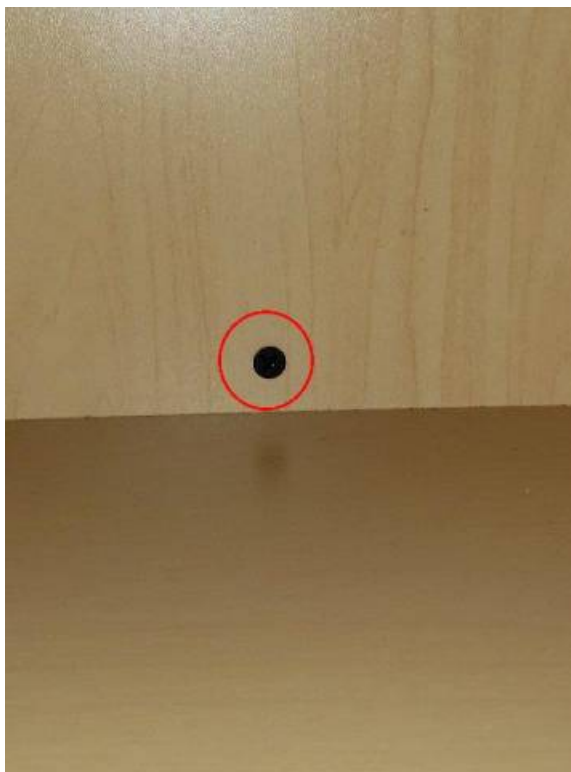
| <i>Cabinets:</i> | <input type="checkbox"/> | <input checked="" type="checkbox"/> | <input type="checkbox"/> | Cabinets appear serviceable with no noticeable wear, Drawers and cabinet doors are all properly aligned and operable. Cabinets installed with wrong type screws. Drywall counter-sunk screws may shear and pull away from wall. Replace with proper stainless pan-head cabinet screws (usually found in paint department in hardware stores) |

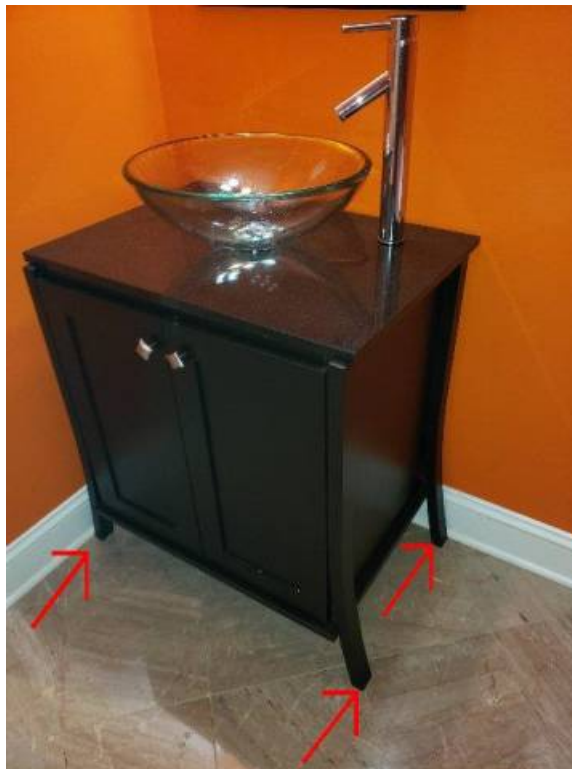
Basement Bath: Vanity cabinet not attached to wall or floor and loose on floor. Properly secure legs the floor.

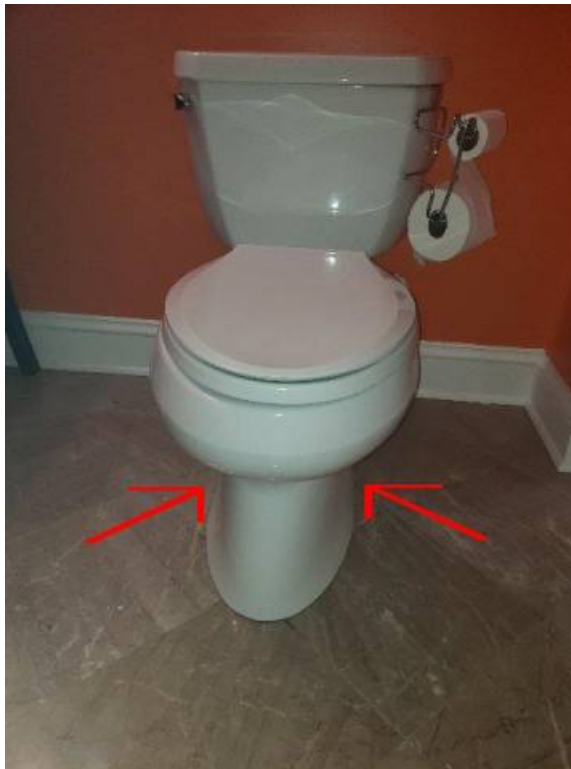
Basement Bath: Toilet bowl is loose at flange, Flange bolts may be detached from flange. Toilet should be reset by plumber with new wax ring if tightening bolts fail to secure toilet in place.

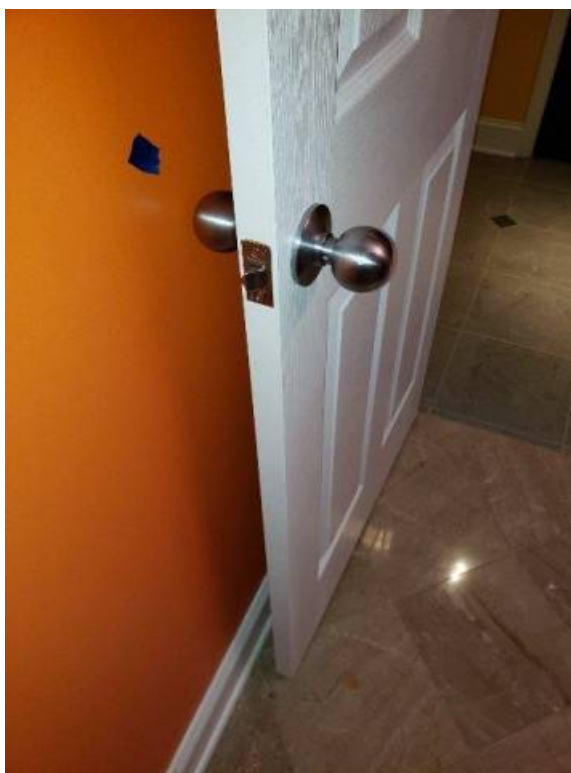
| | OK | MM | RR | |
|---|---|---|---|---|
| | <input type="checkbox"/> | <input type="checkbox"/> | <input checked="" type="checkbox"/> | Primary Bath: Door rub/sticks/won't close, Trim down door so that the door will properly latch. |

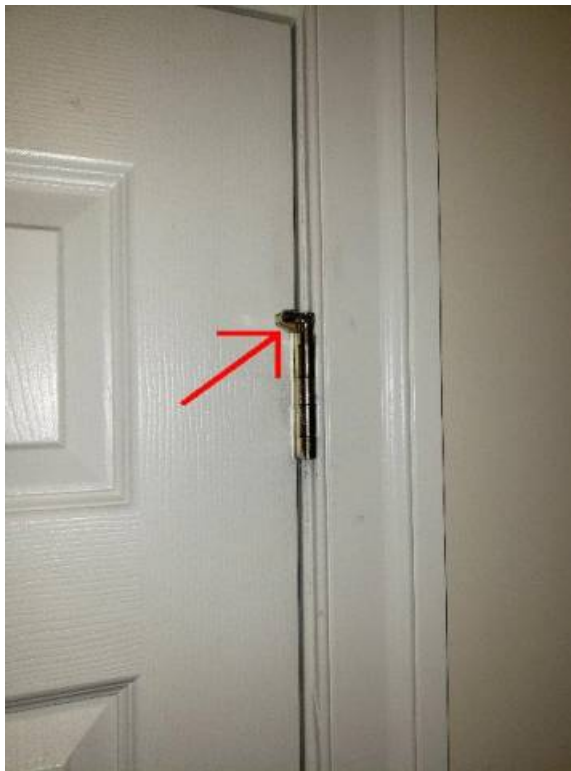
General condition appears serviceable,
Door stop needed on door.

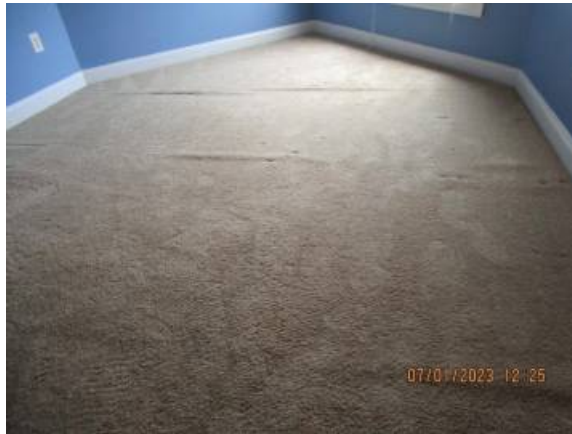
| <i>General:</i> | <input type="checkbox"/> | <input checked="" type="checkbox"/> | <input type="checkbox"/> | Flooring specialists would be needed for repairs. The floor covering material is primarily hardwood, ceramic or marble tiles and carpet upstairs, General conditions appears serviceable. Upper Floor bedrooms and hall carpeting is loose. Carpet in good condition but should be stretched by carpeting specialist. Professional carpet cleaning needed in primary bedroom. |

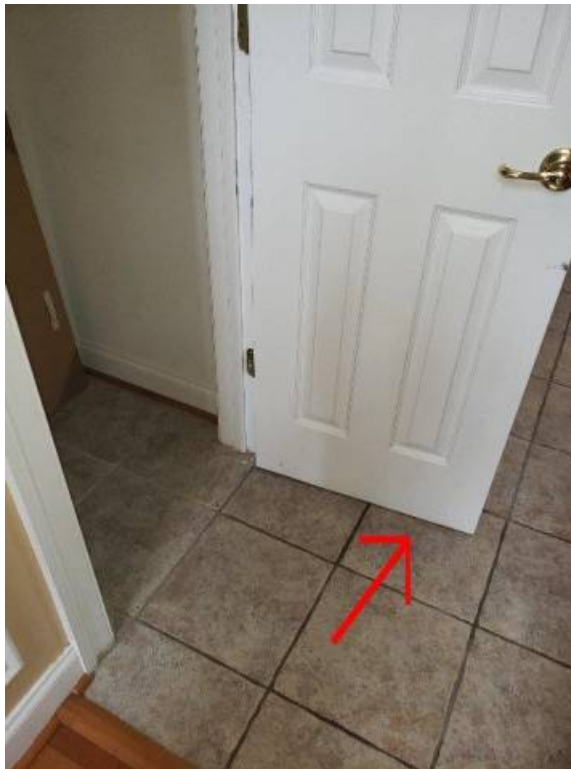
| <i>General:</i> | <input type="checkbox"/> | <input checked="" type="checkbox"/> | <input type="checkbox"/> | Coat closet door rubs/sticks. Repair door to properly operate. |

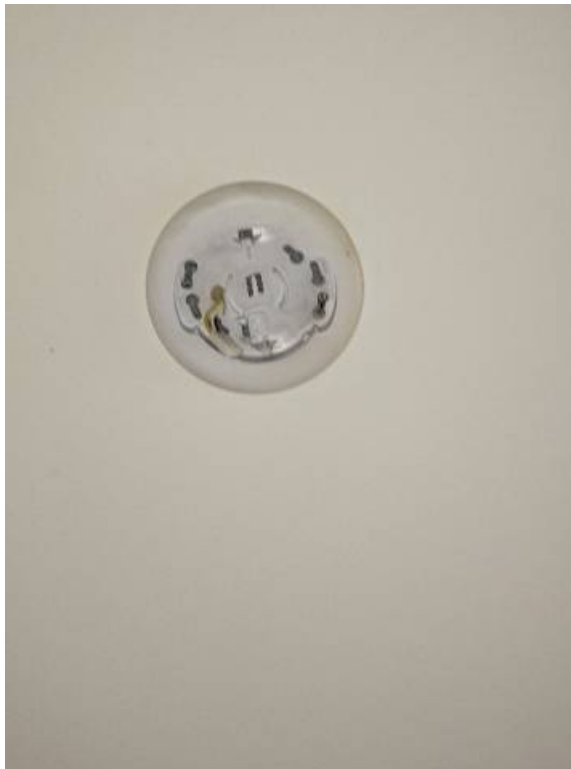
2 Smoke detector covers missing on upper bedroom level and Hall and bedroom. Several Other detectors failed to operate when tested. Suggest replacing or repairing all smoke detectors to operate properly.
