Report: Main St 123 Address: 123 Main Street

Confidential Inspection Report

123 Main Street
Vienna, VA

August 24, 2023

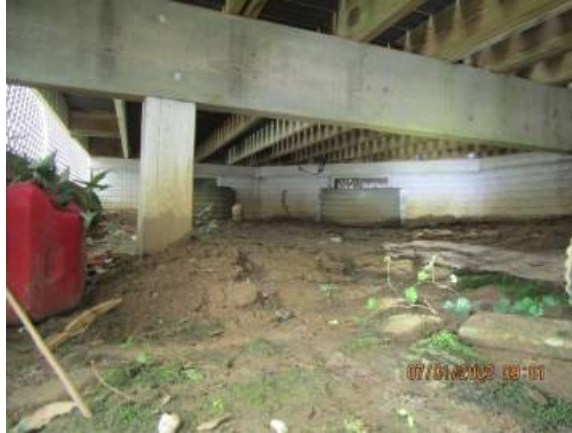
| Condition: | <input checked="" type="checkbox"/> | <input type="checkbox"/> | <input type="checkbox"/> | Synthetic decking with pressure treated framing. Deck is attached from underneath and is properly flashed behind ledger board. This prevents water from traveling along lag screws into the ban-board. Visible components properly constructed and appears serviceable. Steps to Deck: PVC Handrails are serviceable. Steps to Deck are serviceable. (Suggest Gravel stones under deck to prevent erosion and provide a dry surface for storage.) |

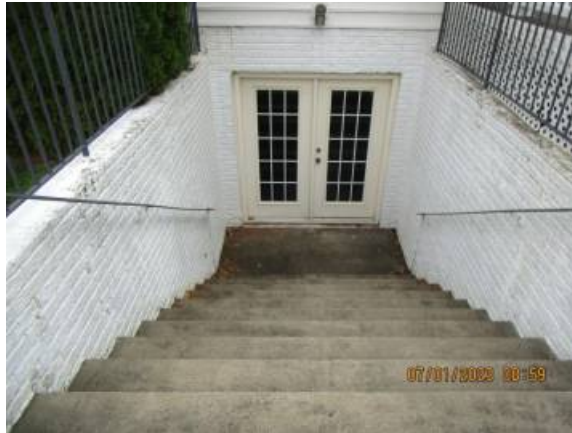
Basement is fully accessible from back door, Basement is mostly finished, except for the utility room.

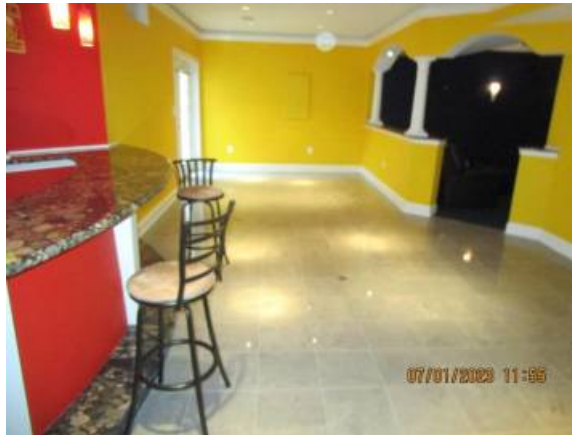
Wall Materials are covered with drywall. Exposed portions of the interior foundation perimeter walls appear to be satisfactory.

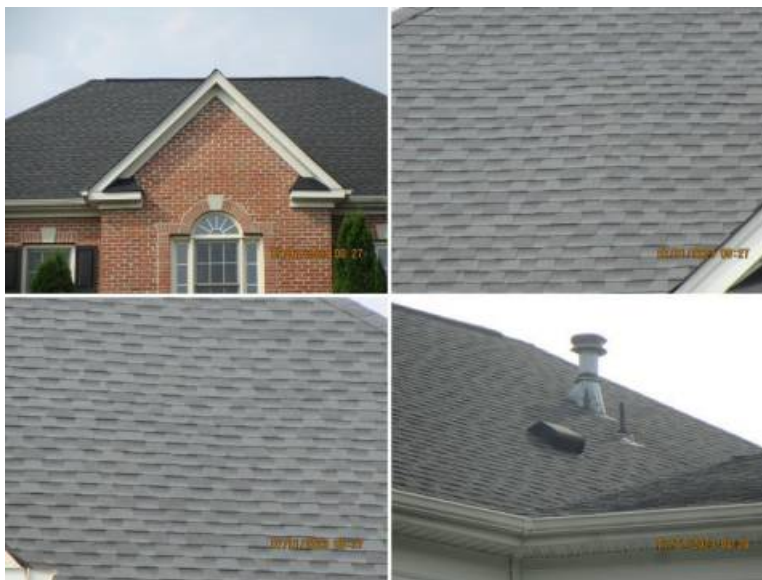
Style: Hip style roof.
Roof Access: Viewed from ground with binoculars.
Roof Covering: Composition, fiberglass asphalt shingles, Architectural heavy duty design, Age normally up to 30 years. Age of roof appears to be approximately 18 years old.

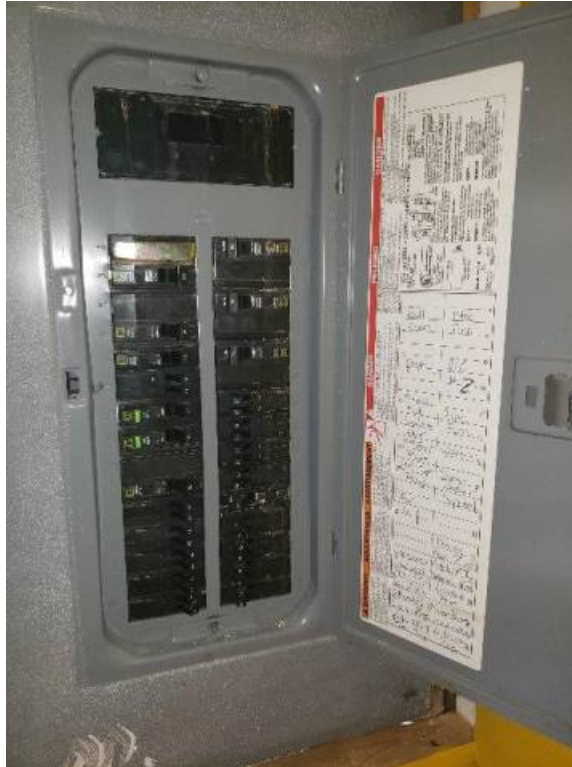
☒ ☐ ☐ 4/0 Aluminum, Anti-oxidant paste has properly been applied to both hot legs in panel, Appears serviceable.

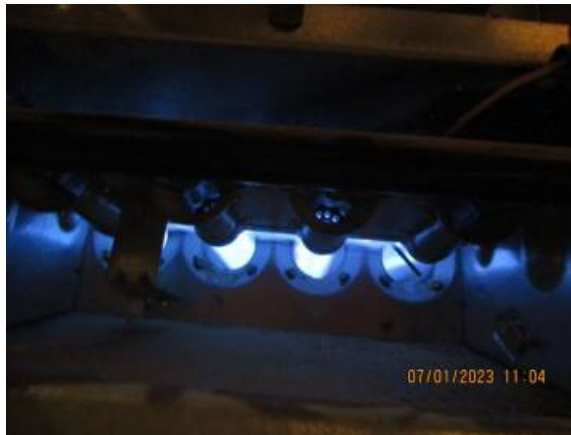
| | OK | MM | RR | |
|---|---|---|---|--|
| Fuel Source: | <input checked="" type="checkbox"/> | <input type="checkbox"/> | <input type="checkbox"/> | Zone 1, Gas Fired Furnace appears properly installed and plumbed. Electronic ignition is provided, All burners are firing off evenly. No gas leaks are detected. Appears serviceable. |

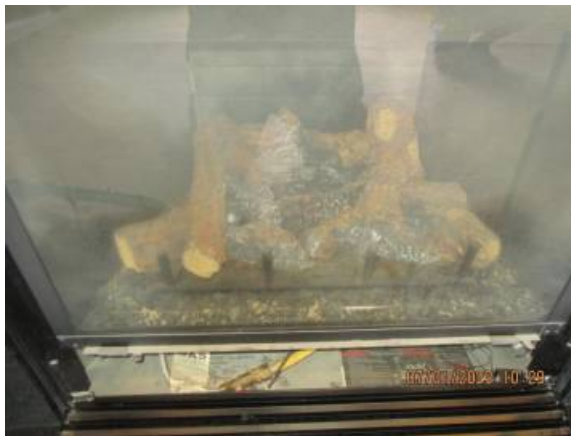
| <input checked="" type="checkbox"/> | <input type="checkbox"/> | <input type="checkbox"/> | Direct Vent Fireplace-Operation is serviceable. Direct vent fireplace with wall switch control is serviceable. Glass doors and screen are operational. Fireplace is operational at time of inspection. Lighting instructions underneath firebox. (Glass cover in need of cleaning) |

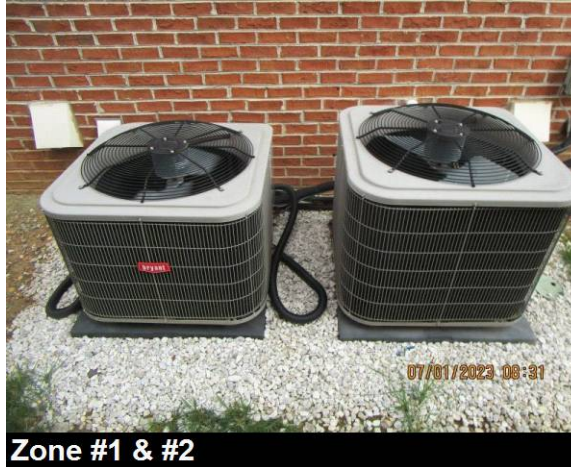
| <i>Capacity / Age/ Condition:</i> | <input checked="" type="checkbox"/> | <input type="checkbox"/> | <input type="checkbox"/> | A-410 refrigerant being used, 2 Zone System: Zone #1: 3.0 Tons, 30 amp maximum. Manufacturer Age: 2017 Zone #2 HP: 3.0 Tons, 30 amp maximum. Manufacturer Age: 2017 |

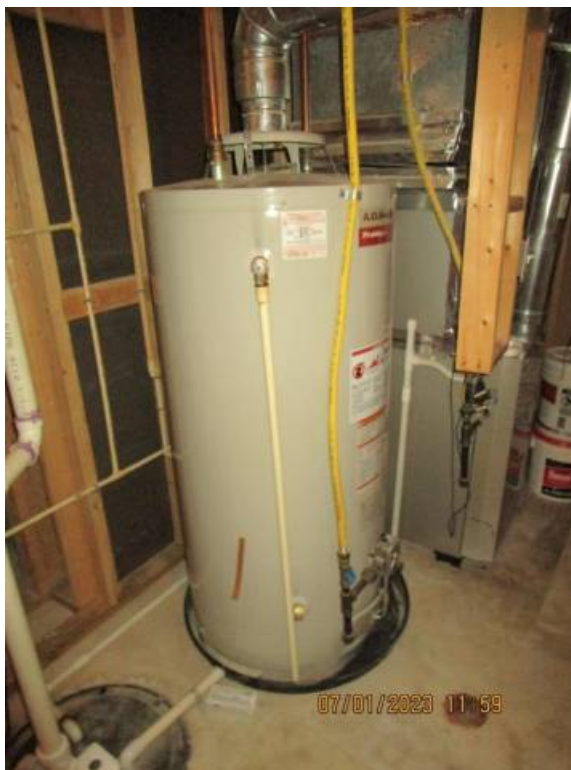
Expansion tank is waterlogged. Plumber needed to replace expansion tank. Suggest expansion tank be relocated over water heater at Cold Water line with proper hangers.

Size: 75 Gallons, 75,000 BTU's. Manufacturer Age: 2005. Water heater is 18 years old.

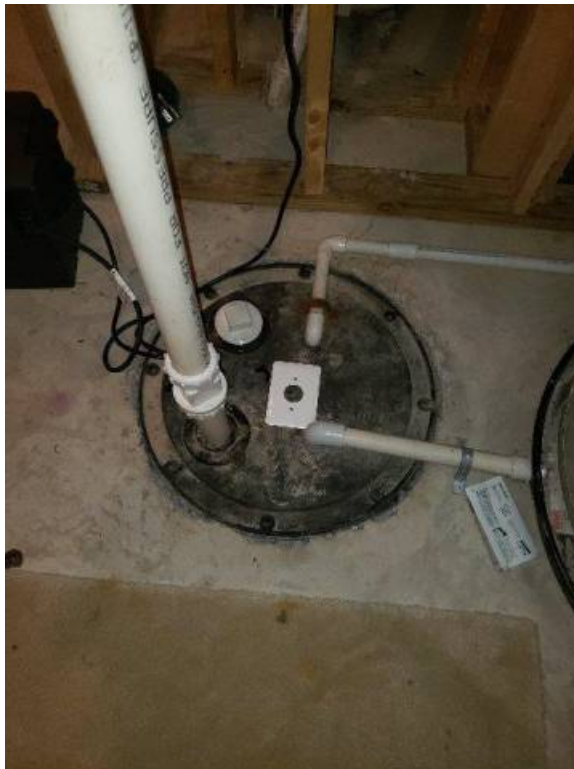
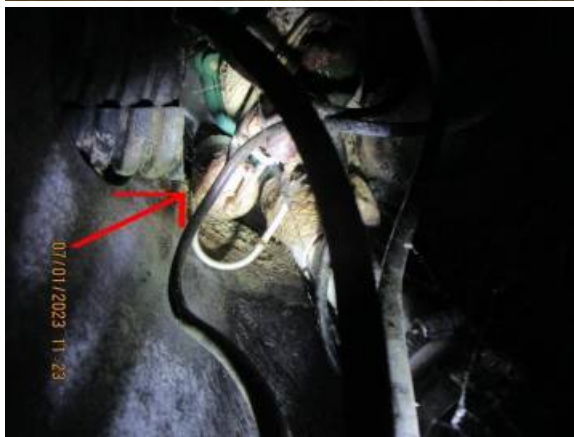
Identify end of exterior drain. Suggest stones or pop-up device be installed where drain daylight.

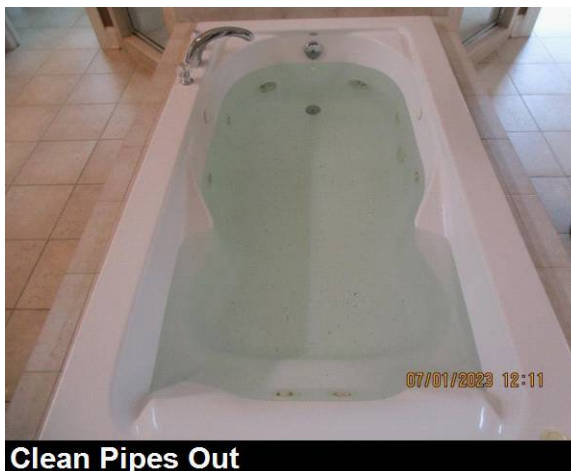
Clean Pipes Out

No leaks detected, Valves and shower heads are serviceable.
 Hydro-spa was operated and is functional, (supply pipes should be periodically flushed with anti-bacterial cleanser), GFCI Reset located at wall and motor access is at side.
 All bathroom fixtures were properly installed and operational. No leaks noted and water pressure was good.
 Showers and tubs are all serviceable.

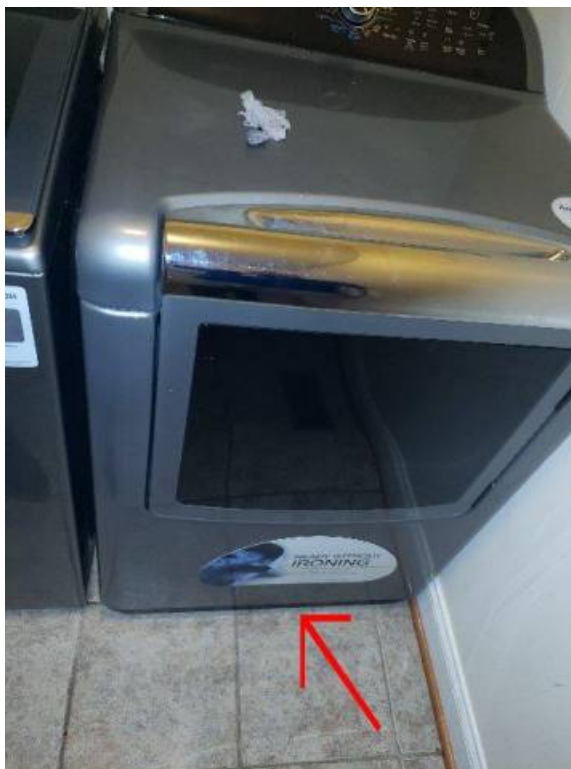
CAUTION: No overflow pan installed (not required over utility room, but good idea)

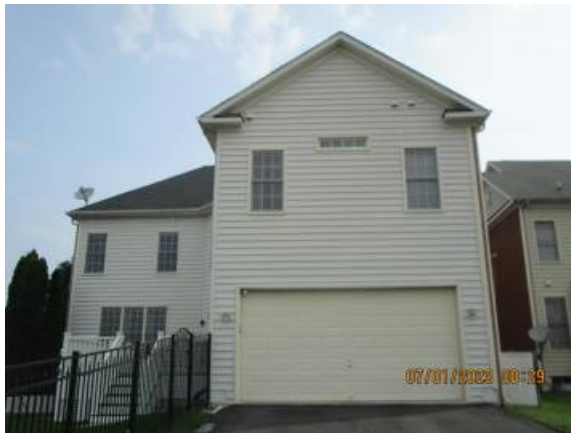
The house has a two car garage that is built-in under house.

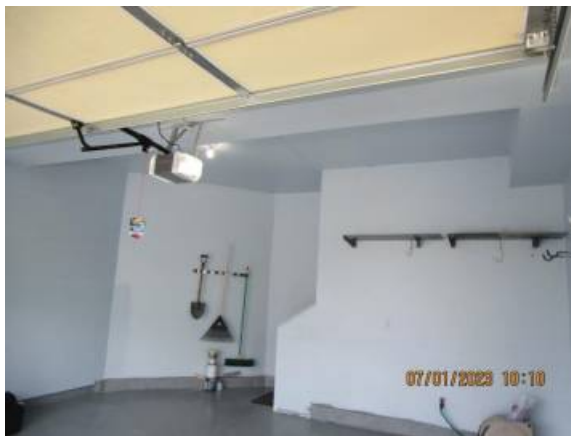
| <input checked="" type="checkbox"/> | <input type="checkbox"/> | <input type="checkbox"/> | Automatic Overhead Door Opener is operational, Automatic reverse features are operational. Safety pull present on opener. |
